# 7 Things Every Playground Owner Should Know About the Accessibility of Their Playground Surfaces

A publication of the U.S. Access Board and the National Center on Accessibility

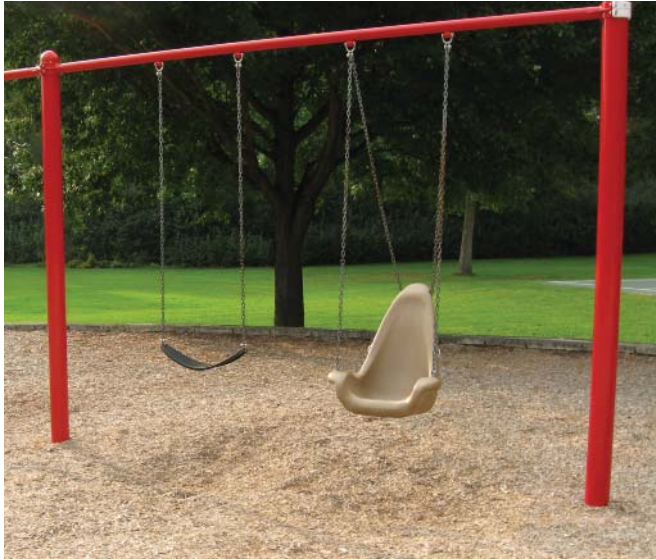
## Engineered Wood Fiber (EWF)

ASTM defines EWF as processed wood ground to a fibrous consistency, randomly sized, approximately 10 times longer than wide with a maximum length of 2 inches. Free of hazardous substances. Not to be confused with wood chips.

Improper installation and/or maintenance can result in undulation across the horizon of the surface affecting running slope, cross slope and change in level. Product material should be installed in layers and compacted in order to achieve an accessible route and level clear ground space at equipment. Surface material is likely to displace at heavy use areas with motion, such as at swings, slides, sliding poles, climbers, spinners and teeter totters. Displaced material should be raked level and compacted before additional fill is added.

Sites installed with EWF were found to have the highest number of accessibility deficiencies within the first year of installation. Because EWF is a loose fill surface, it is frequently observed with accessibility deficiencies related to running slope, cross slope and change in level. EWF has been observed with undulation across the horizon of the surface area. The undulating surface material creates changes in level, running and cross slopes exceeding the maximum allowable standards resulting in non-compliant accessible routes to play components. It is critical for the manufacturer/supplier and the playground owner to communicate the process for installation. In most instances it is necessary for the loose material to be installed in layers, watered and compacted in order to achieve an accessible route and level clear ground space at equipment. Some playground owners consider the installation of EWF as an opportunity to use volunteers to assist in compaction by running drum roller teams across the surface area.

EWF sites were recorded in need of maintenance most frequently and earliest in the NCA study. Sites surfaced with EWF were commonly found to have an undulating surface material creating changes in level, along with running and cross slopes exceeding the maximum allowable standards. This would result in non-compliant accessible routes to play components. Large areas where the loose material had been displaced under heavy use areas with motion such as at swings, slides, sliding poles, climbers, spinners, and teeter totters were observed at all of the sample sites with EWF. A kick-out area at a swing could be as large as 3 ft. x 8 ft. with a depth of more than 5 inches. The accessibility standards require the minimum 30 x 48 inch clear floor space for transfer to/from the accessible play components to have a level surface with less than a 2.08 percent cross slope in all directions. The displaced surface material at locations such as the bottom of slides, a swing, or ground level play component rendered the accessible route to the play component non-compliant with the accessibility standards. Maintenance issues

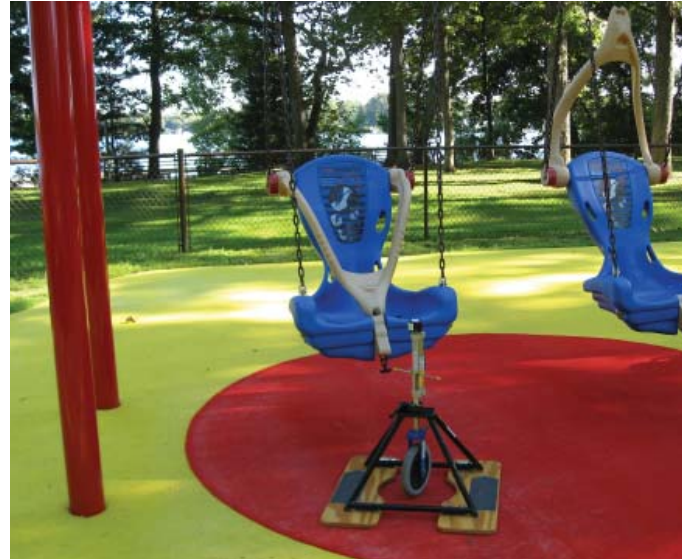
## Hybrid Surface Systems (HYB)

Multi-layer system where the base layer may consist of either contained or loose particles like shredded rubber or carpet pad. The top layers may be outdoor carpeting, artificial turf, or rubber top mat.

Seams may separate or detach from the border creating changes in level and openings affecting the accessible route. Shifting of loose fill in the base layer may affect running and cross slopes. The artificial turf top layer may experience build-up of static electricity requiring application of anti-static solution.

Two of the three different types of HYB systems (outdoor carpet and artificial grass) were installed by contractors representing the manufacturers. These surface systems required installers experienced with laying the sub-surface, adjoining seams, and affixing the surface material to the border. Separation at the seams appeared to be the most prevalent concern following installation. Repairs to seams must be made by the contractor and costs are dependent upon the terms of the product warranty.

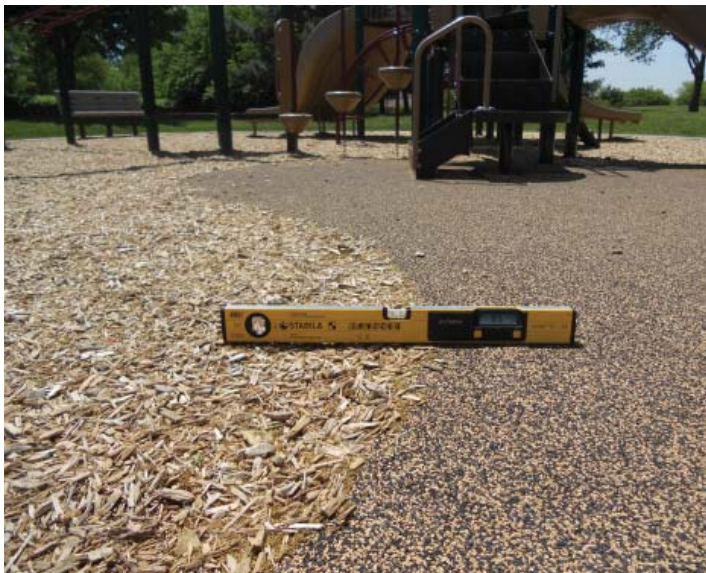
*The maximum running slope for the ground level accessible route must not exceed 1:16 or 6.25%. Using a digital level is one option for measuring the slope of the ground level accessible route.*

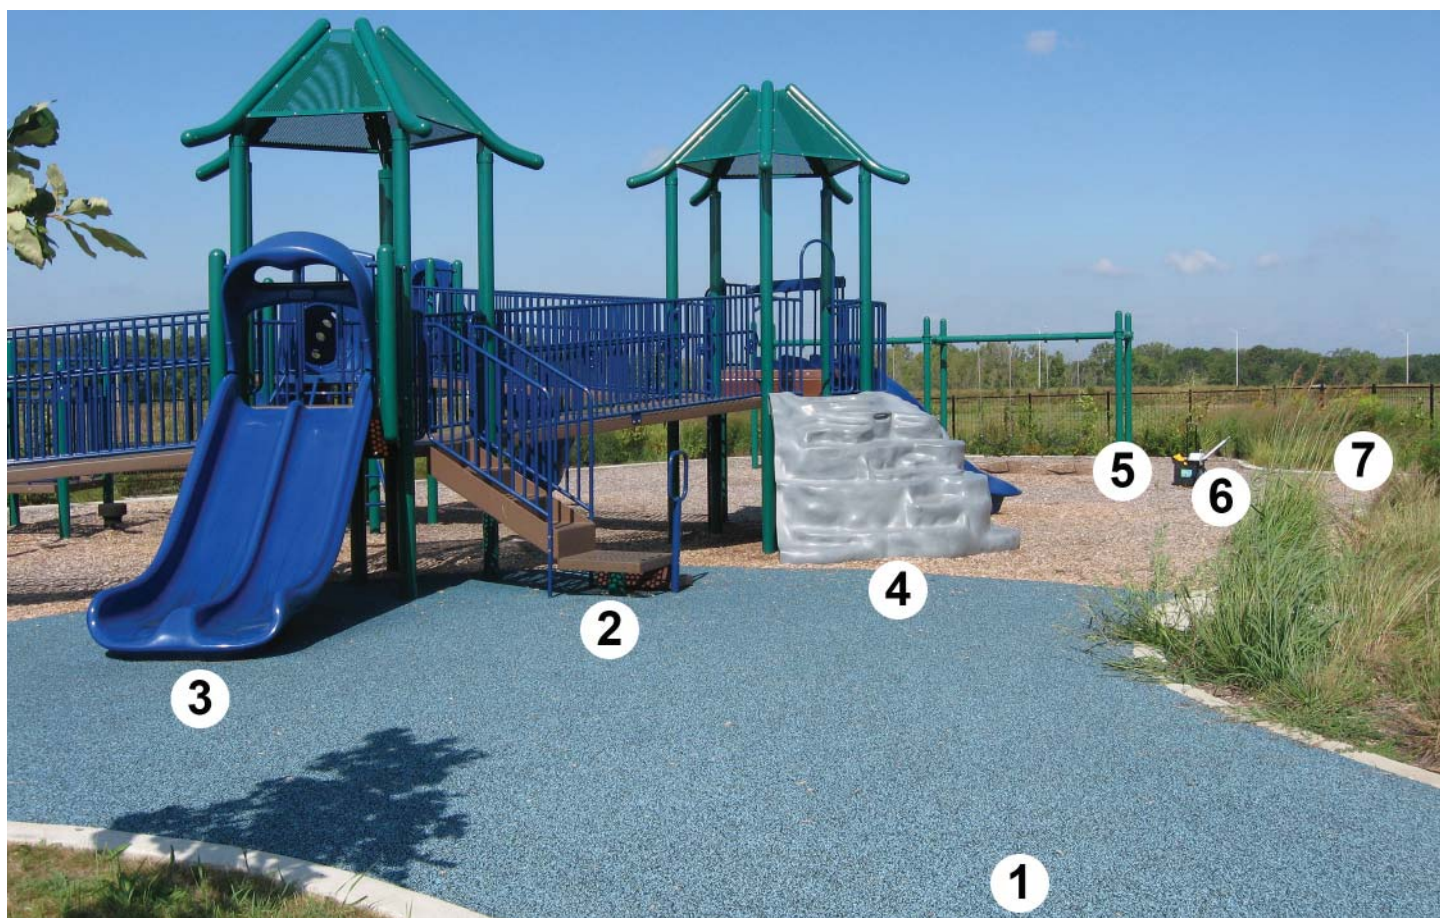
When conducting an assessment of the ground level accessible route, it helps to start with “the big picture” -- to view the play area in its entirety. Begin at the entry to the play area. Identify the accessible play components and the path to entry/egress for each piece of accessible equipment. Then focus in on the accessible route. Each segment of the route should be assessed for compliance with the accessibility standards. Look for the worst areas, those locations where the slope or cross slope may exceed the standard, where changes in level may be too high, or where openings may be too large.

One method to assess the ground level route using the photo above would be to look at each route segment, such as:

The purpose here is to look for deficiencies in order to make corrective actions. All of the technical provisions must be met through the entire route for it to be considered accessible. Thus, each segment should be assessed for slope, cross slope, change in level, openings, firmness and stability (which will be discussed in greater detail in the next sections). It would be inaccurate and incomplete to only measure slope at one segment, cross slope at another, or to average the data for three segments. Every segment of a route is used by people with disabilities, therefore it is critical that each segment meet the minimum standards.

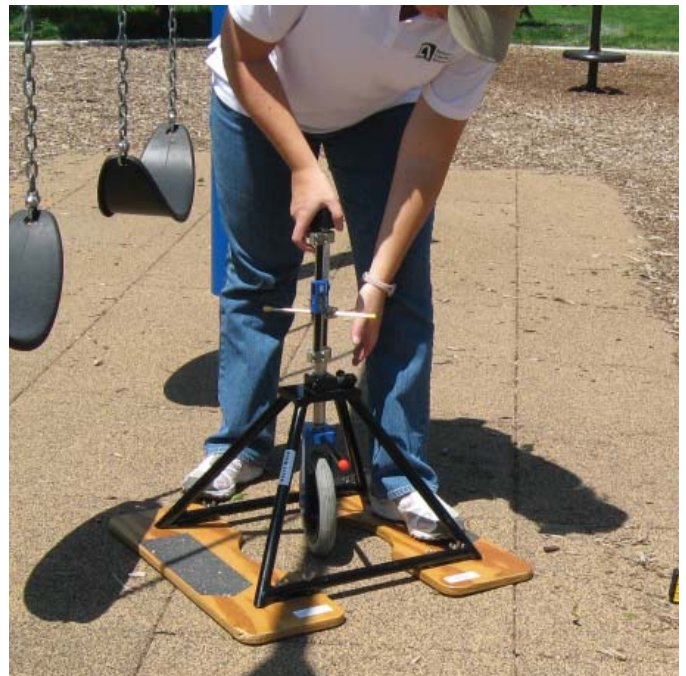
*A Rotational Penetrometer (RP) is used here to measure the firmness and stability of the surfaces.*

The RP design includes a wheelchair caster placed on a spring loaded caliber in a metal tripod frame which suspends the caster about 6 inches over the surface. When the caster is released, the spring load gauge replicates the force of an individual in a wheelchair over a given surface. The penetration into the surfaces is measured for readings of “firmness” and “stability.” National experts recognize the use of the Rotational Penetrometer as a portable and relatively easy device to use for surface testing. The field test method with the RP can be added to the assessment process just as measurements for slope, cross slope, change in level and openings are taken along segments of the accessible route for the play area. The RP can measure those segments for firmness and stability. This can be valuable in assessing how an installed surface performs over time.

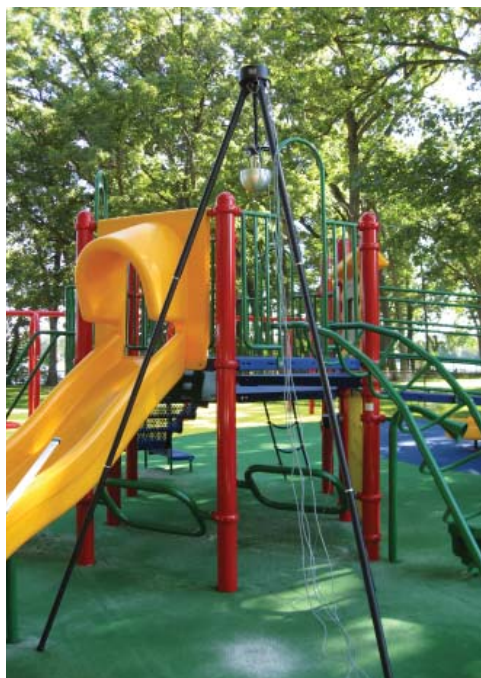
*A TRIAX is used here to test impact attenuation or the play surface’s ability to absorb a fall and reduce severity of injury.*

In the field, ASTM F1292-99/04 Standard Specification for Impact Attenuation of Surface Systems Under and Around Playground Equipment is also known as the “head drop test.” It is a test to make sure the surface is resilient enough to prevent a life-threatening injury from a fall. A 6 inch diameter aluminum hemisphere in the shape of a child’s head is dropped from the top of a tripod based on the fall height of play components. The aluminum hemisphere, or missile as it is called, contains an accelerometer. When dropped, the impact attenuation of the surface is measured in G-max and by the Head Injury Criteria (HIC). G-max is a measurement of the maximum acceleration, while HIC measures an integral of the acceleration time. The maximum values allowable by the standard are 200 for G-max and 1,000 for HIC. A TRIAX is the instrument used to conduct this test in the field.

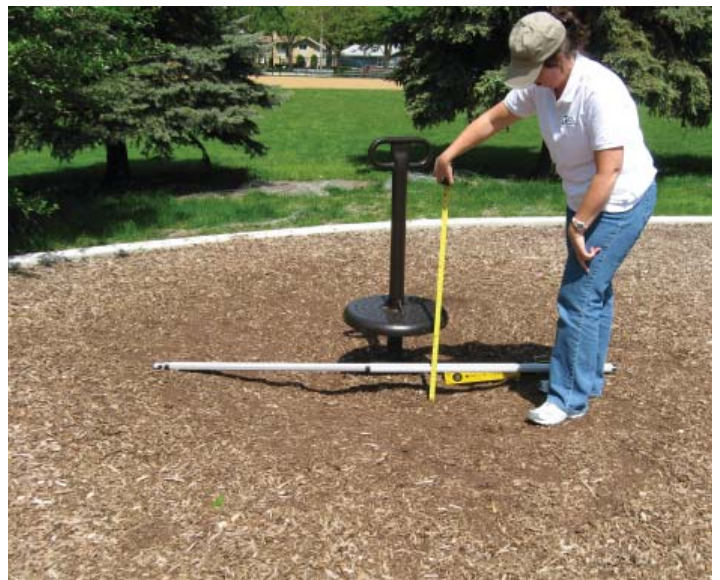
*Loose fill materials, like EWF, may experience undulation of the surface material and or displacement under heavy use areas with motion such as at swings, slides, sliding pools, climbers, spinners and teeter totters. This will require the surface material to be raked level, filled and compacted so that the clear ground space is level in all directions for a safe transfer onto and off the equipment.*
