Forest  
Products  
Laboratory

General  
Technical  
Report  
FPL-GTR-138

# Field Performance Testing of Improved Engineered Wood Fiber Surfaces for Accessible Playground Areas

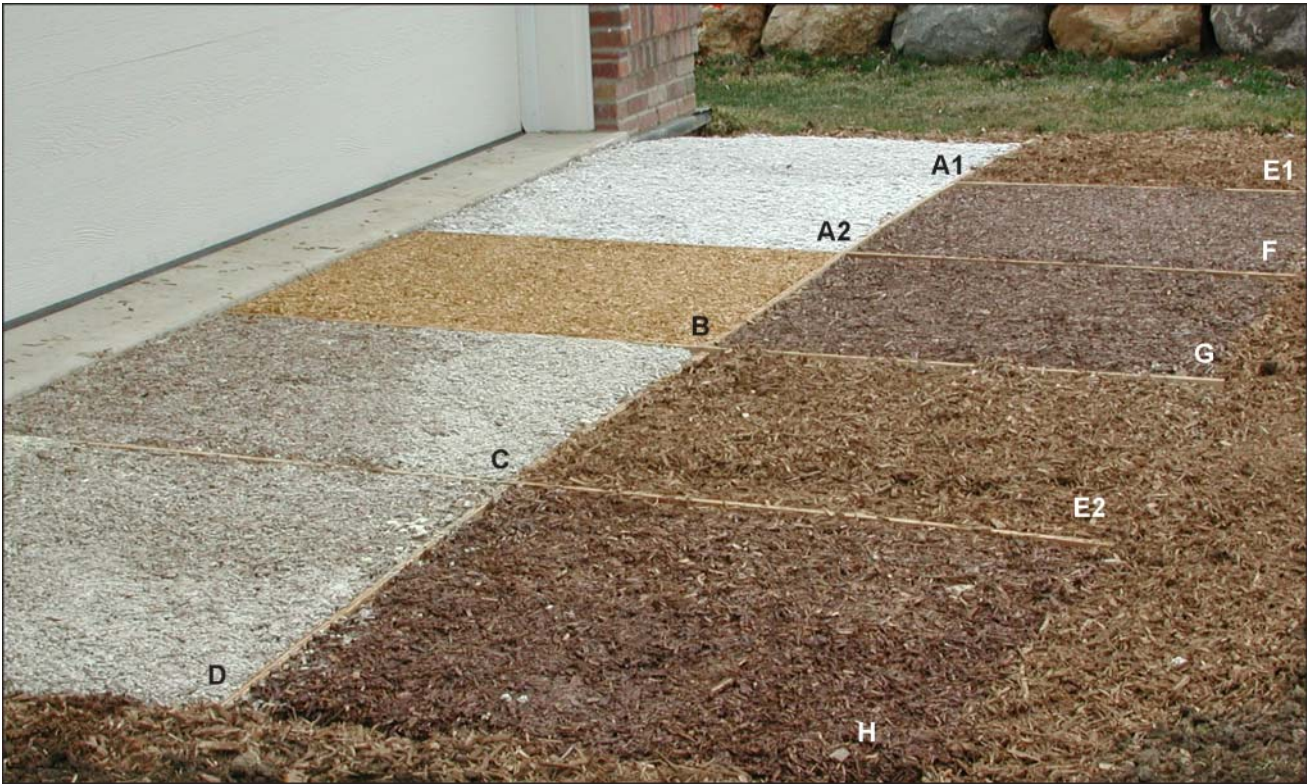
Figure 1—Overview of test surfaces in Madison, Wisconsin. See Table 1.

by 12 in. deep) (Fig. 1). Seven surfaces had a top layer of bonded resin-EWF; one surface served as a full-depth control. In addition, two surfaces (A1 and E1, Fig. 1) were placed on a slope to assure drainage of the entire test surface. All surfaces were made of EWF, as defined by ASTM F2075-01 (ASTM 2001). All test surfaces were compacted to simulate the finished surface of a play area. Because there is no industry, governmental, or association definition or standard for compacting EWF, we followed playground industry installation practices.

An interfacial treatment was used for two surfaces (D and G, Table 1, Fig. 1). A 1.2- by 1.2-m (48- by 48-in.) single-ply layer of lightweight polyolefin landscaping geotextile was placed between the unbonded and bonded layers of these surfaces. The geotextile was intended to provide continuity for the thinner bonded surface layers in the event of a fracture through the entire thickness. Should this happen, the layer could be thrust from its original position and become a hazard on the remaining bonded surface.

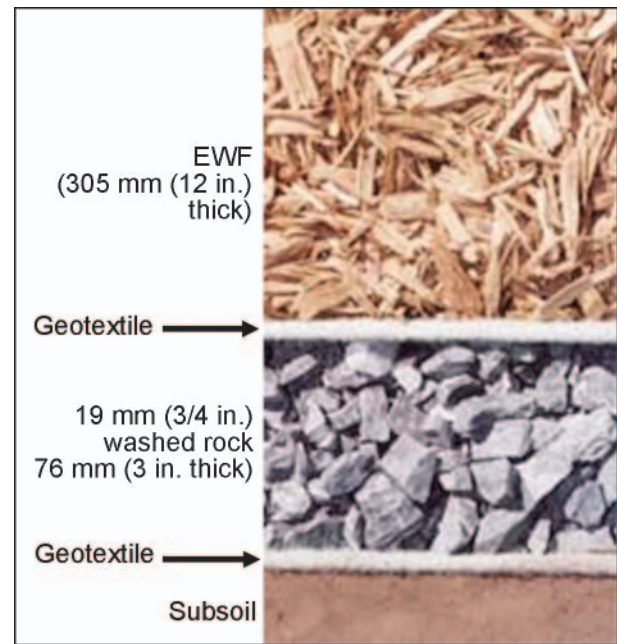
**Figure 2—Representational cross-section of installed surfaces. Note that EWF thickness includes thickness of any stabilized EWF layer.**

In accordance with general EWF design and construction practice, the full-depth surfaces were prepared to the requirements for permanent playground surfaces (Fig. 2). Installation began on February 27, 2002, and surfaces were bonded within 6 weeks. Installation proceeded as follows:

1. Excavate area 380 mm (15 in.) in depth with a minimum of 1% grade to ensure proper drainage. Remove roots, stones, and vegetation.
2. Place diversion along slope above test area to ensure no direct site drainage into surfaced area.
3. Cover entire subgrade with one layer of geotextile. Overlap courses of geotextile by 125 mm (5 in.).
4. Cover excavated surface to 75-mm (3-in.) depth with washed 18-mm (3/4-in.) stone.
5. Cover entire drainage bed with one layer of geotextile. Overlap courses of geotextile by 125 mm (5 in.).

6. Spread EWF to depth 1.5 times target depth and compact uniformly, resulting in density 50% greater than bulk (uncompacted) density.
7. Hand rake for smooth finished surface.

8. Install plywood retaining borders (15 mm thick by 100 mm wide, 0.6 in. thick by 4 in. wide) between each pad.
9. Prepare and install top surface<sup>1</sup>

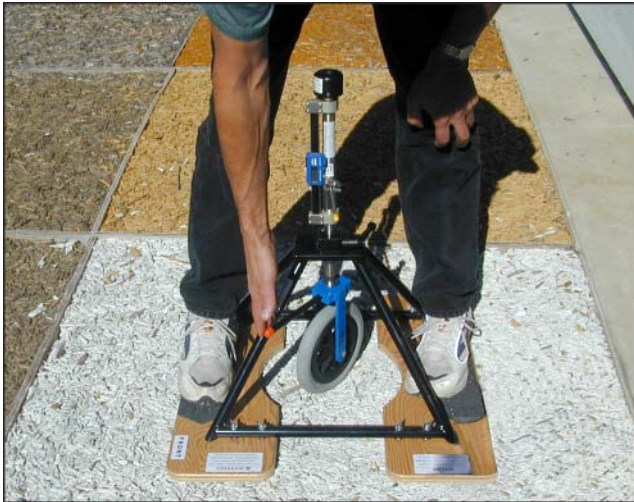
**Figure 3—Rotational penetrometer in use on surface A2.**

Periodically over the 6-month exposure and again after the 6-month impact tests, all surfaces were tested with a Beneficial Designs rotational penetrometer (Figs. 3 and 4). This device subjects the surface to a low-speed rotational bearing test meant to simulate the weight and action of a front caster wheel on a wheelchair. The procedures used were based on the draft Rehabilitation Engineering and Assistive Technology Society of North America national standard test method for the firmness and stability of ground and floor surfaces (RESNA 2000), with the exception that only one reading was recorded instead of the average of five readings. This test provides objective measures of firmness and stability of surfaces. It has been correlated to the work measurement done in ASTM F1951 (ASTM 1999b) for a wide array of surfacing and floor coverings. The test was conducted 1 week after surface installation and each month thereafter using the rotational penetrometer and protocol for assessing the bearing/rotational indentation on each surface (Axelson and Chesney 1999). Each surface was tested at a unique location around its periphery.

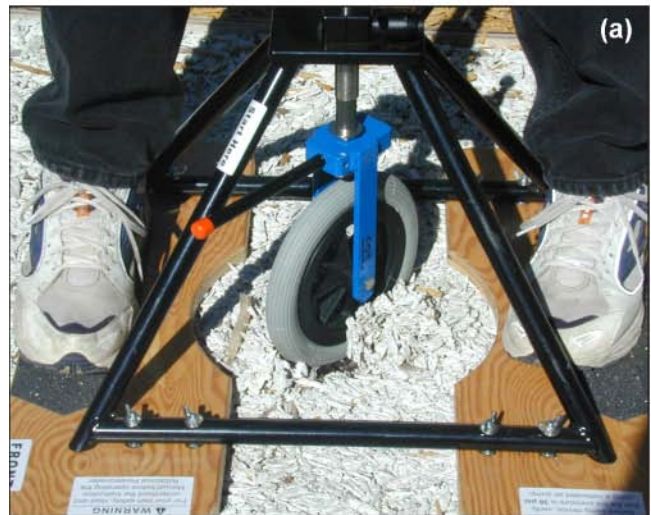
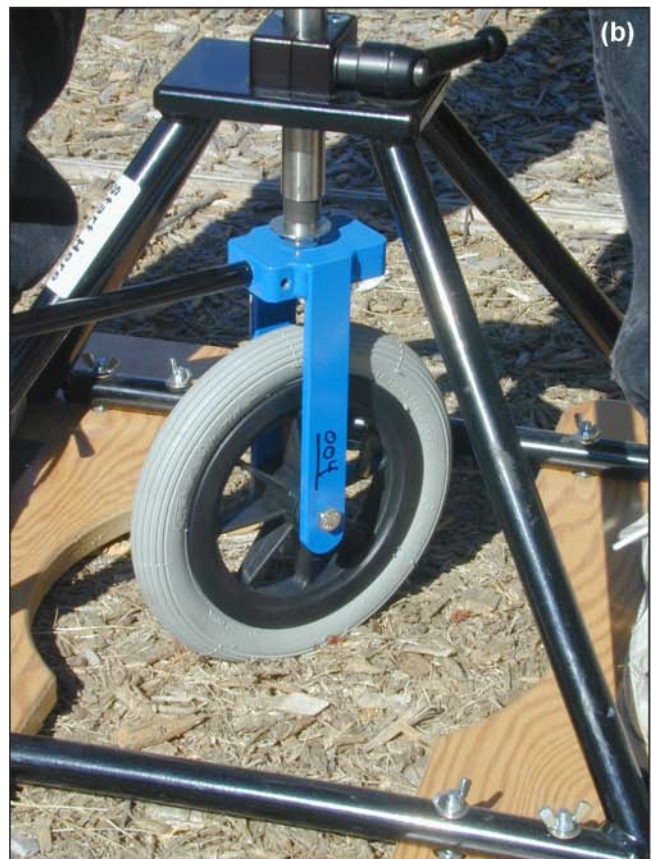
**Figure 4—Accessibility test with rotational penetrometer. Stability readings taken after caster wheel was rotated 360°. (a) Poor stability of surface A2 indicated by amount of silicone-coated EWF displaced by rotated caster wheel; (b) good stability of surface G.**

In the 6 months of testing, the silicone surfaces (A2 and B) were rated as moderately stable or even as not stable on many occasions, whereas the other treatments were typically rated as stable (Fig. 4). The unstabilized EWF surface (E2) was consistently rated as moderately stable. In several isolated instances, the latex and non-foaming polyurethane surfaces were rated as moderately stable.

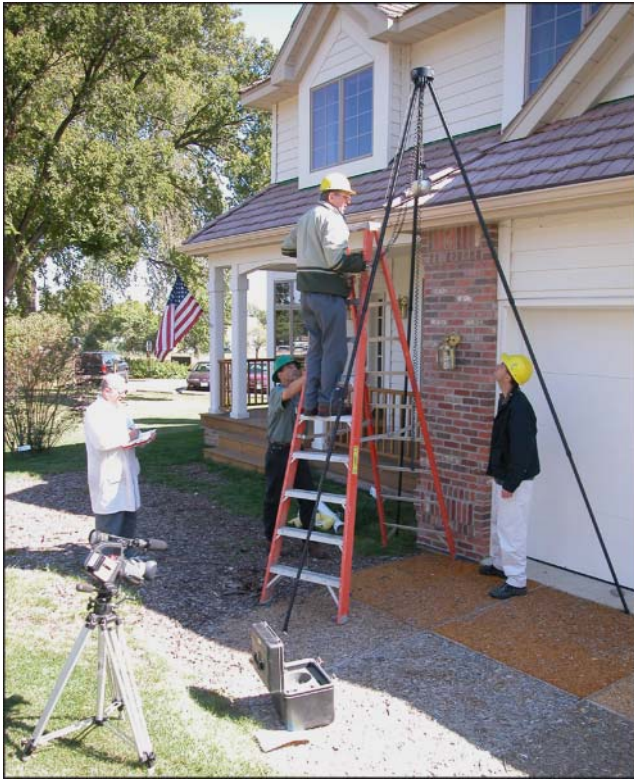
**Figure 5—Impact attenuation test. A 4.5-kg (10-lb) hemispherical impact head was installed 3 m (10 ft) over surface D. Ted Illjes (on ladder) holds instrumentation package connected to impactor by coiled wire. Doug Zeager awaits arrival of impactor, which will be caught on first rebound from surface.**

Impact tests were conducted by Doug Zeager and Ted Illjes of Zeager Brothers, Inc. (Middletown, Pennsylvania). The impact test was completed after the test surfaces had been exposed for 6 months. ASTM F 1292–99 (ASTM 1999a) test specifications and F355–95 (ASTM 1995) test methods were used at a constant test drop height of 3.05 m (10.0 ft). Three impact tests per test surface were run in sequence according to the specifications. A tripod was erected to center the impactor over each test surface (Fig. 5). Per ASTM F355, the instrumented headform was mounted on a magnetic release over the center of the surface.

The first impact was ignored, and the data were collected from the second and third impacts. Immediately after impact testing, EWF samples were obtained from each surface for moisture content determination.

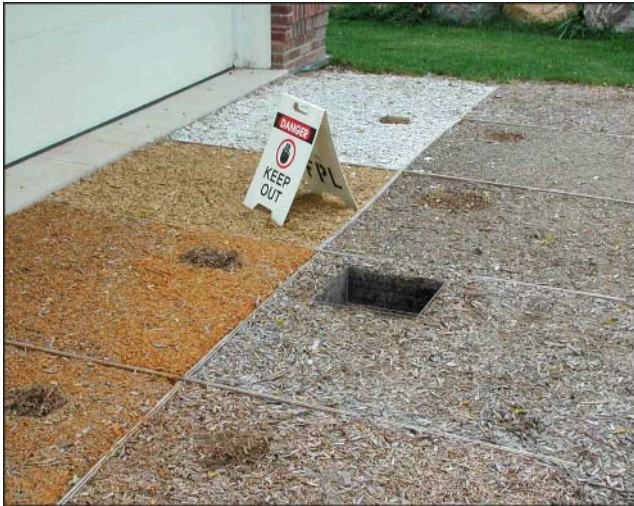
**Figure 6—Removal of test sample for determination of density and moisture content of surface layer and EWF beneath surface.**

Because of the in-situ nature of the tests and the size of the test surfaces, we did not have a means for nondestructively evaluating moisture content or durability of these surfacing systems. Thus, we relied on visual evaluation of the surfaces during the 6-month exposure period; moisture content samples were removed after the test period (Figs. 6 and 7). Data on surface layer density and moisture content and EWF moisture content just beneath the surface layer are shown in Table 5 and Figure 8.

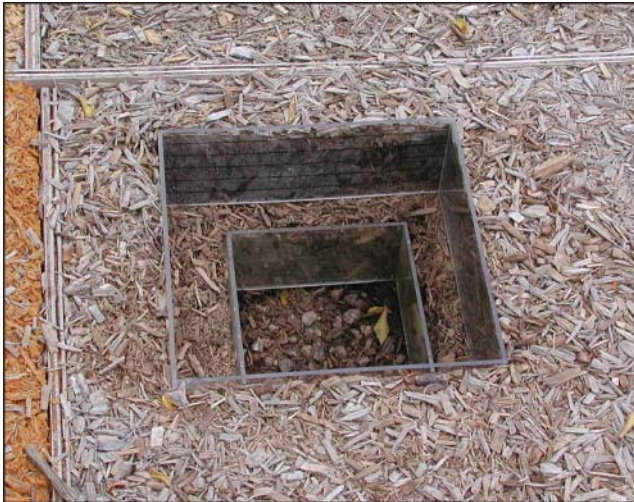
**Figure 7—Archeological-type excavation for determining moisture profile of E2 surface. Note gravel at bottom of 0.3-m (12-in.) excavation.**

Another representation of EWF moisture content is shown in Table 6 and Figure 9. The trendline fitted to the data of the E2 moisture profile (Fig. 9) indicates that saturation occurred at a depth of approximately 100 mm (4 in.) and continued to the drainage bed. Additional study would yield knowledge of the rate of decay under these very wet/ saturated conditions. We have no quantified model for predicting the loss (decay) of woody material under these moisture conditions. We could easily presume that the development of a stabilized resin–EWF system with reduced moisture content in the unbound EWF would result in a beneficial reduction of decay rate. This, in turn, would extend the life of stabilized EWF in situ on playground surfaces.

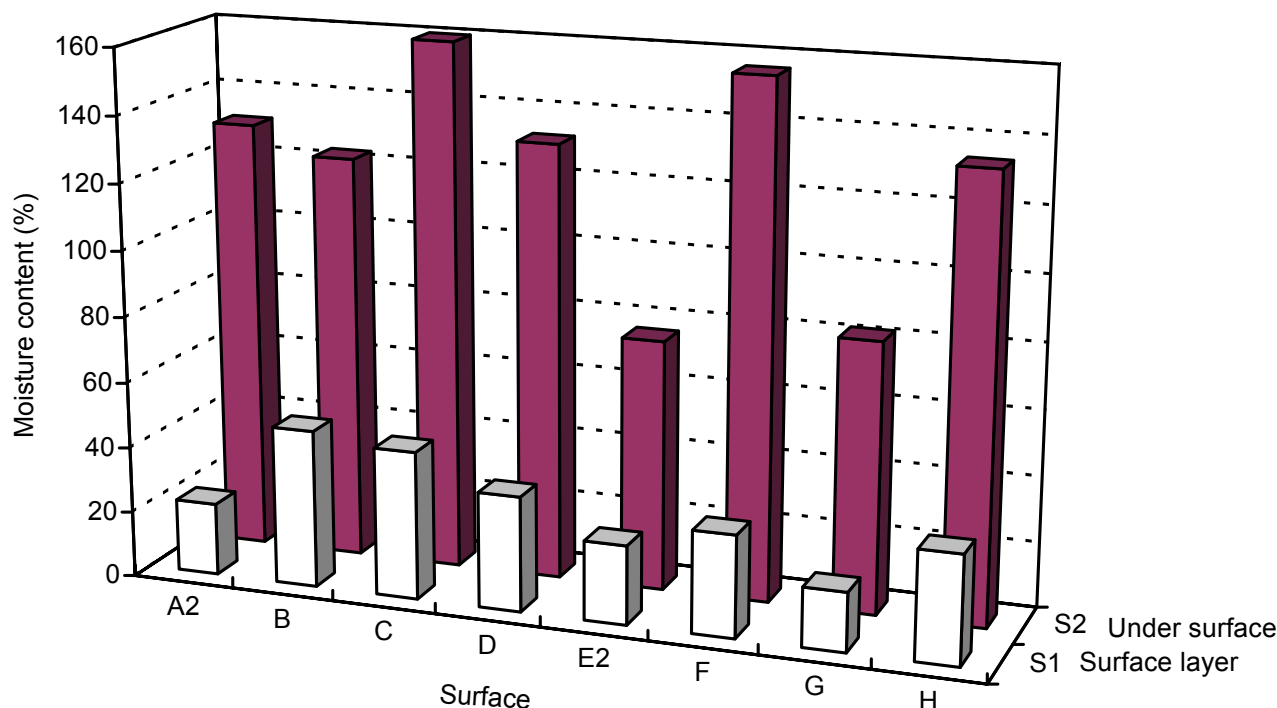
**Figure 8—Comparison of average moisture content of stabilized surface layers with moisture content of EWF immediately beneath surface.**

Moisture content measurements indicated that the bonded surface layers, on average, were not as wet (by weight) as the E2 surface (unstabilized EWF). The measurement of moisture content is misleading because of the nonhygroscopic properties of the binder. However, the EWF under the stabilized surfaces was wetter than the bonded surface layers. This suggests that the EWF–resin surface layer retarded the drying process, which, in turn, saturated the underlying EWF.

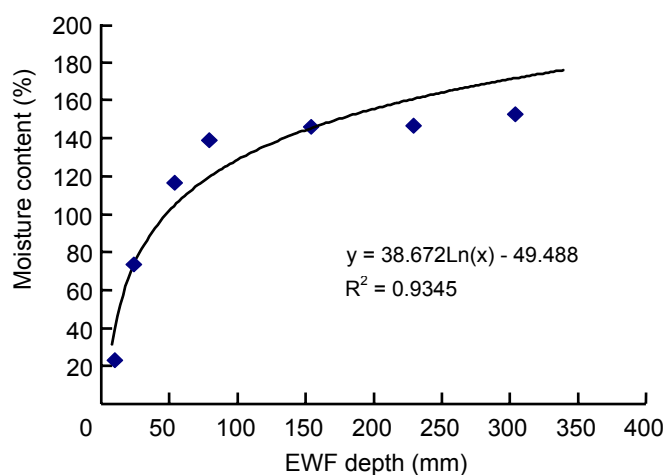
**Figure 9—Profile of moisture content through EWF of surface E2 and trendline fitted through measurements.**
