FPL-GTR-154

# Stabilized Engineered Wood Fiber for Accessible Playground Surfaces

## Installation and Serviceability Results: Governor Nelson State Park, Wisconsin

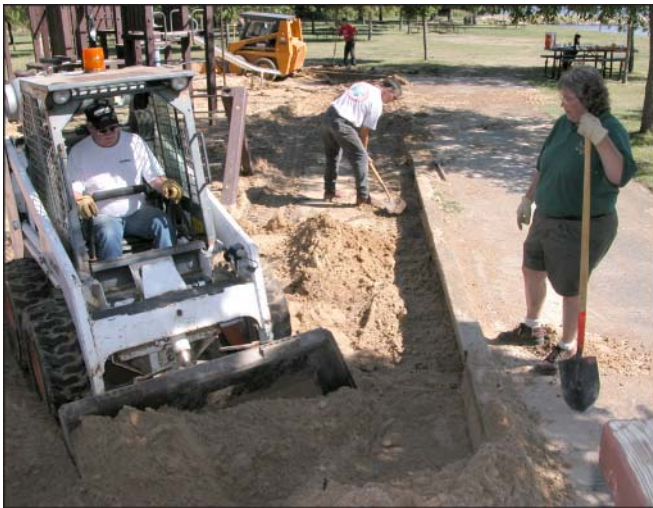
**Figure 2—Removal of sand from existing playground surface.**

Our efforts began by removing the existing sand surface to a depth of 0.38 m (15 in.) (Fig. 2). All roots, stones, and vegetation were removed. Much of the tonnage of sand was moved by two skid-steer loaders, but significant amount required handwork by a dedicated and hardworking volunteer crew from the Waunakee Rotary and a local chapter of Telephone Pioneers of America. The work crew also included employees of the park, the Wisconsin Department of Natural Resources, and the Forest Service. The majority of the clean sand was used to replenish the adjacent beach at the park and the remainder was piled in a wooded site nearby. Approximately 12 h of equipment time and 48 h of personnel time were required to remove the sand.

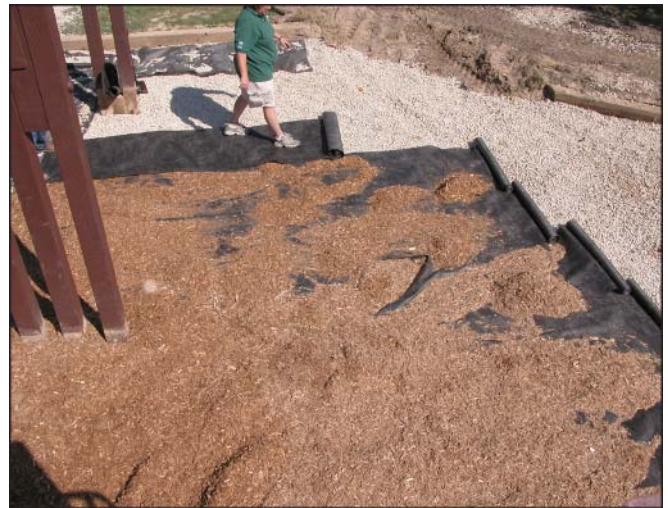
**Figure 4—Completion of drainage system; second layer of fabric laid over drainage rock.**

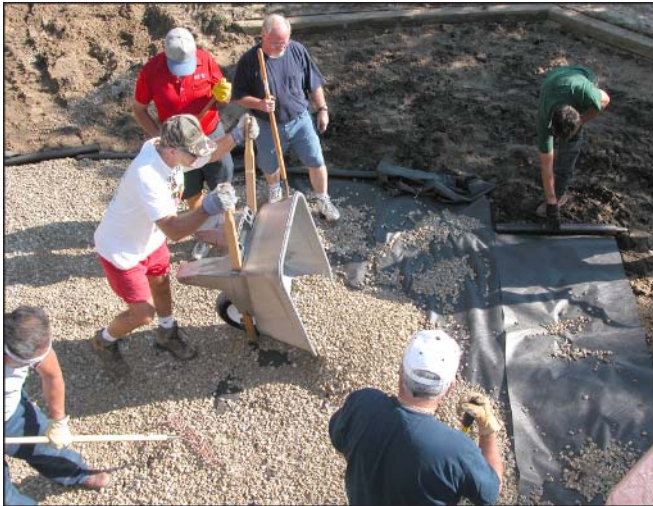
**Figure 3—Placement of drainage fabric and rock on playground subsurface.**

fabric was placed on the surface, followed by a 0.08-m (3-in.) layer of 18-mm (3/4-in.) washed, angular drainage rock (Fig. 3). Half the rock was placed using a skid-steer loader and the other half was placed manually using wheelbarrows. All the rock was shoveled and raked by hand to a uniform depth. Another layer of geotextile fabric was laid on top of the rock layer (Fig. 4). Handfuls of rock were thrown on the fabric to keep the wind from blowing it out of place. The layers of geotextile fabric kept soil and fiber from clogging the rock and thus preserved the drainage quality of the rock layer. Approximately 25 metric tons (28 tons) of rock was used. Placing the rock and geotextile required 25 h of manual labor and 3 h of skid-loader use.

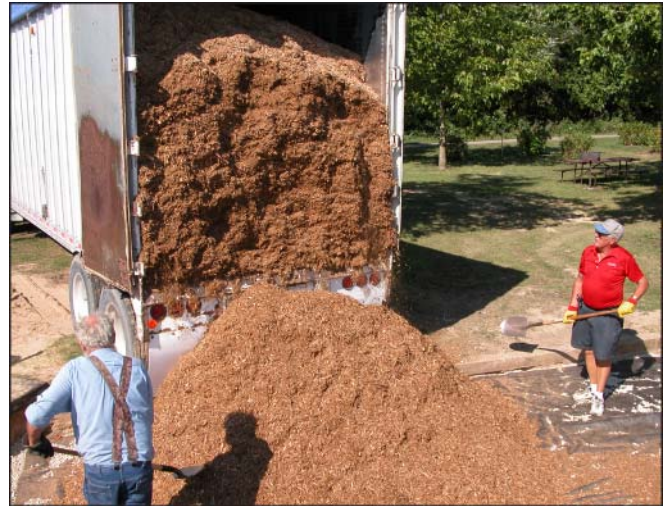
**Figure 5—Application of engineered wood fiber (EWF).**

Fifty cubic meters (66 yd<sup>3</sup>) of EWF, donated by a cooperator (Zeager Bros. Inc.), was obtained from BNB Bedding of Oskaloosa, Iowa, and delivered in a 75-m<sup>3</sup> (100-yd<sup>3</sup>) live-bottom trailer (Fig. 5). The EWF was manually applied to a thickness of 0.3 m (12 in.). One week later, after the surface had been further compacted by usage, approximately 40 m<sup>3</sup>

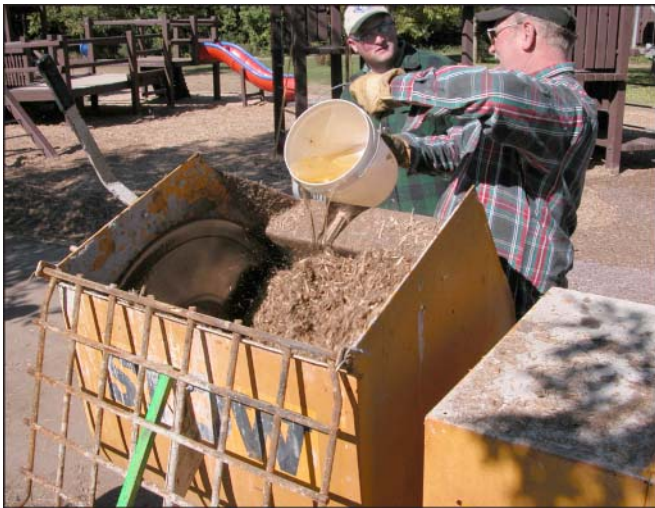
**Figure 6—Mixing of binder and EWF in mortar mixer.**

A portion of EWF was removed from the play area for stabilization. For the polyurethane binder, 38 mm (1-1/2 in.) of EWF was removed and for the emulsion polymer, 64 mm (2-1/2 in.) of EWF. The EWF was placed in a 160-L (40-gal) portable mortar mixer (Fig. 6). The amount of binder added was determined as a proportion (30%) of EWF dry weight (volumetrically equivalent to 0.041 m<sup>3</sup>, 1.45 ft<sup>3</sup>) to 5.3 L (1.25 gal) of Vitri-Turf or 10.6 L (2.5 gal) of Soil-Sement. Weight proportion was 77:23. The EWF and binder were mixed for approximately 3 min. The mixture was transported by polyethylene tray wheelbarrows to the target pad and spread with hand tools to an even thickness (Fig. 7).

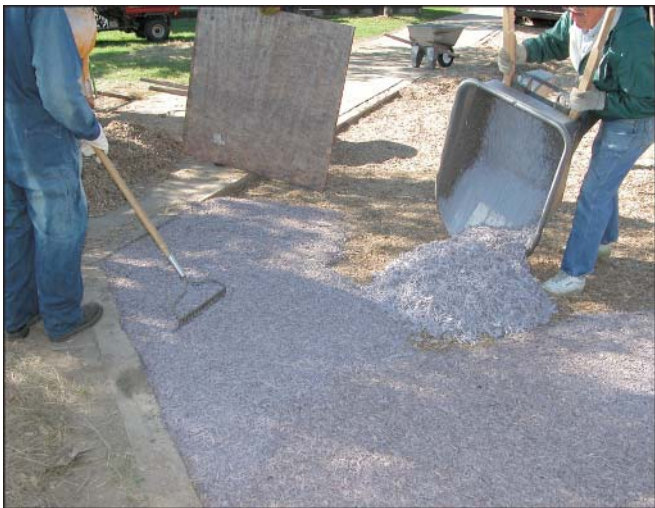
**Figure 7—Leveling and compaction of binder–EWF mixture.**

The area was then compacted and flattened with a 1.2-m by 1.2-m by 16-mm (4-ft by 4-ft by 5/8-in.) piece of plywood

covered with a polyethylene release sheet. To compact the cushioning pad to the full 0.3-m (12-in.) depth required for unbonded EWF, a 90-kg (198-lb) person slowly stepped on the plywood in each quadrant, applying firm pressure.

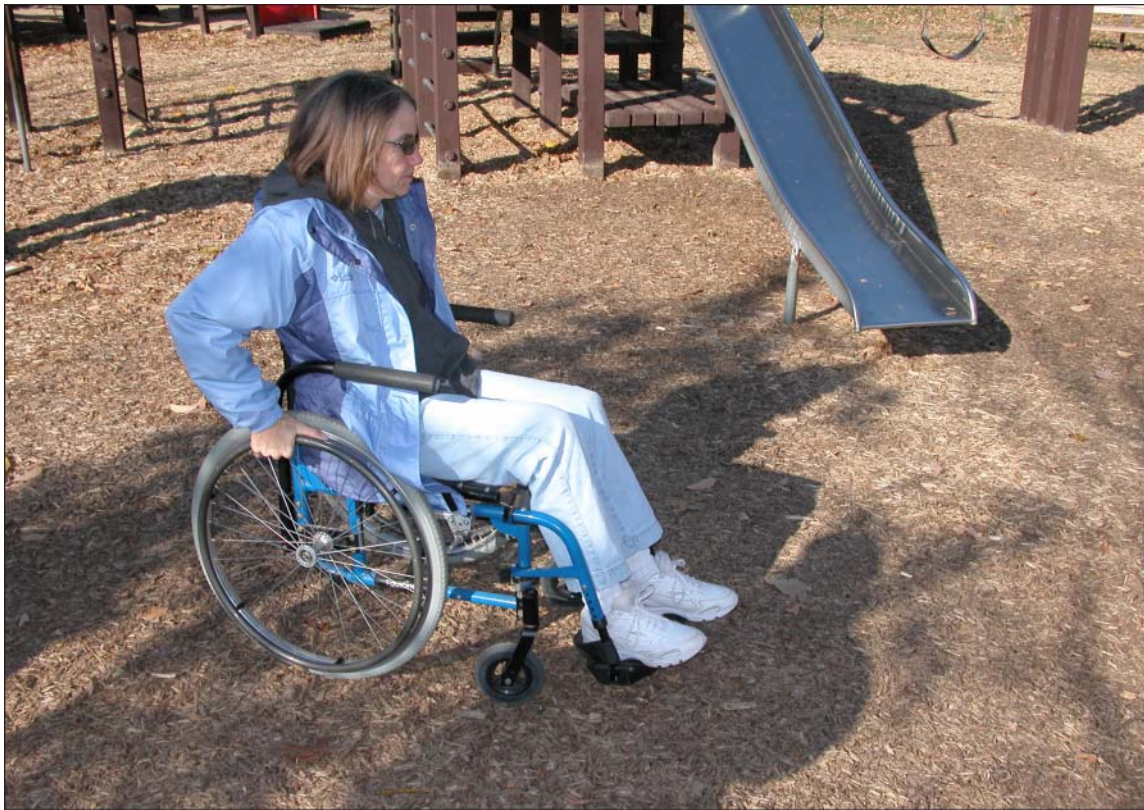
**Figure 8—Completed playground looking north: left, Vitri-Turf SEWF; right, Soil-Sement SEWF; top, EWF. Line of demarcation is below wheelchair footrest.**

The two SEWF surfaces were allowed to cure or bond for 6 days prior to usage. The entire surface was covered with polyethylene sheeting for 3 days to protect it from rain. Within 2 h of placing the Vitri-Turf, the surface was somewhat rigid to slight hand pressure. The Soil-Sement surface did not begin to cure or cross-link until more than 48 h had passed; when the polyethylene sheeting was removed, the surface was still slightly tacky. The area was left open to the air for another 3 days prior to opening the play surface for use. Figure 8 shows the completed surface, with little notable differences between the three surface materials.

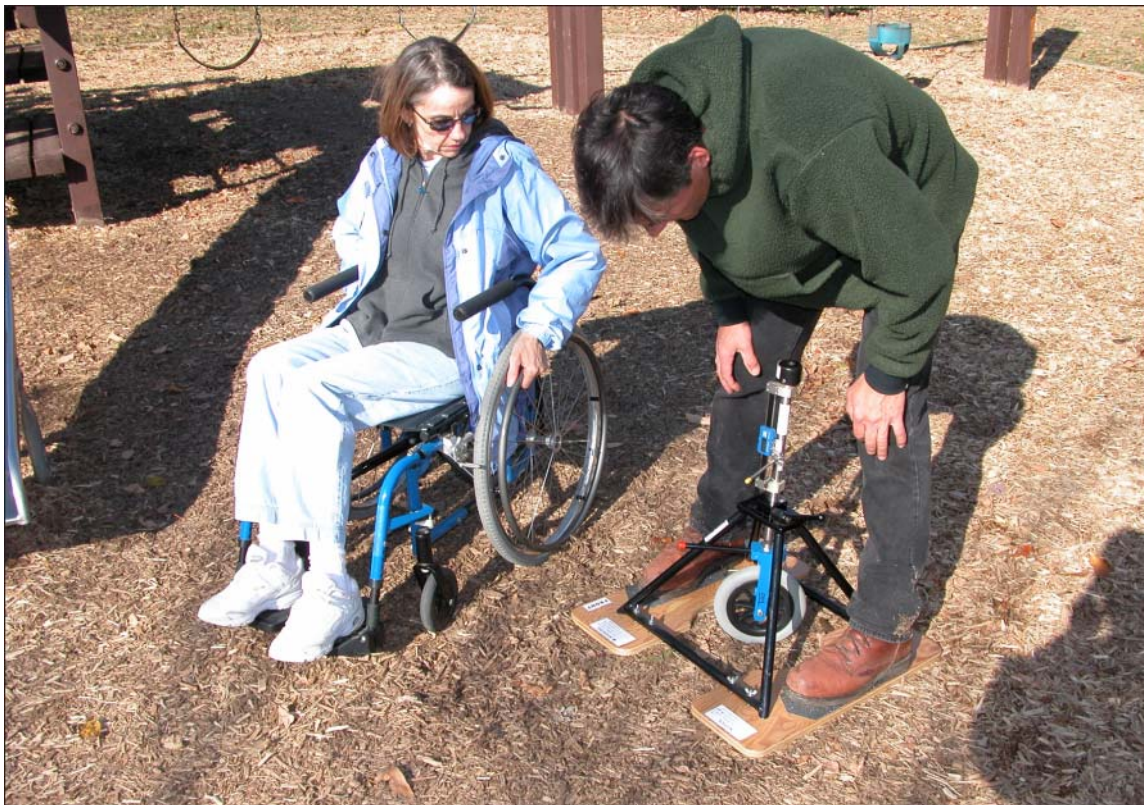
**Figure 9—Measurement of accessibility with rotational penetrometer.**

All surfaces were measured with the rotational penetrometer periodically over the first 6 months of exposure (Fig. 9). This device subjects the surface to a low-speed rotational bearing test that simulates the weight and action of a front caster wheel on a wheelchair. The procedures are based on a draft national standard test method for the firmness and stability of ground and floor surfaces (RESNA 2000), which uses an average of five readings. This test provides objective measures of surface firmness and stability and has been correlated to the work measurement of ASTM F1951, “Accessibility of Surface Systems,” for a wide array of surfacing and floor coverings (ASTM 1999b). The RESNA test was performed 1 week after surface installation and as often as once a week in the first 2 months, using the rotational penetrometer and protocol for assessing bearing/rotational surface indentation (Axelson and Chesney 1999). The device was used on test areas selected as representative of the entire surface.

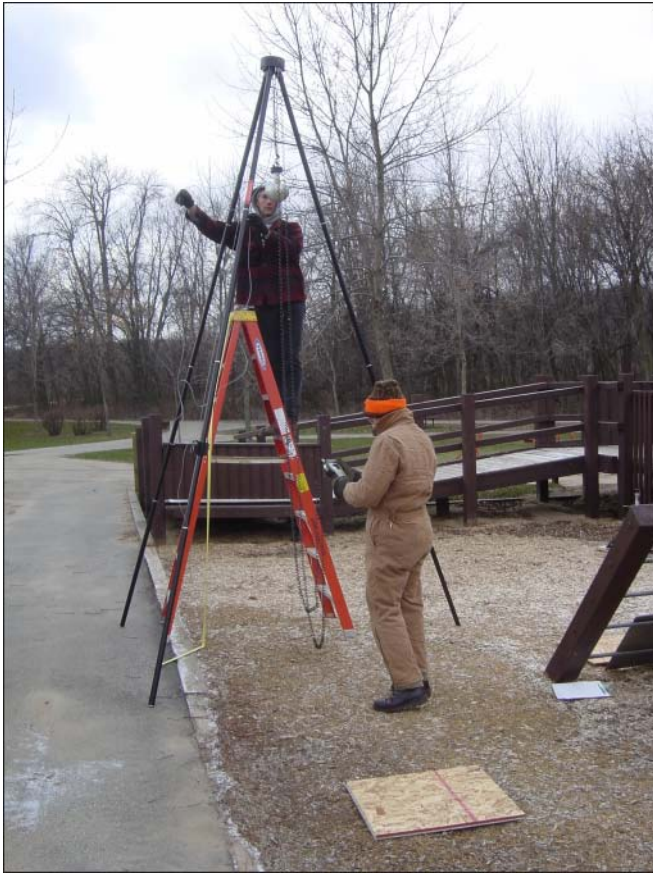
**Figure 10—Impact test setup for drop height of 3.05 m (10 ft).**

Impact tests were performed by a cooperator (Zeager Bros. Inc.) 7 weeks after EWF installation. ASTM F1292–99 test methods were used at a constant test drop height of 3.05 m (10 ft) (Fig. 10). Maximum g levels and head injury criteria (HIC) were measured.

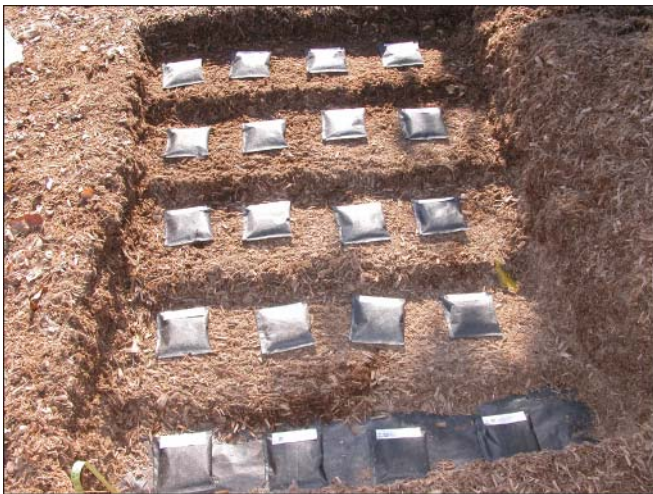
**Figure 11—Biodeterioration samples on EWF surface.**

To learn more about biodeterioration of the EWF playground system, we sampled and oven-dried packets of EWF material and buried them in the unsurfaced portion of the playground. Polyolefin geotextile fiber pouches were each filled with approximately 40 oven-dry grams of fiber (Fig. 11). These biodeterioration samples were placed so as to allow circulation of water and air. The EWF surface was excavated throughout its entire 0.3-m (12-in.) depth to determine the moisture profile of the surfacing system. The samples were buried at depths of 100, 150, 200, 250, and 300 mm (4, 6, 8, 10 and 12 in.) (Fig. 11). One-quarter of the samples was removed at 6 months to provide data on wood fiber moisture content and weight loss. After drying and weighing, the removed packets were reinserted and the area was restored.

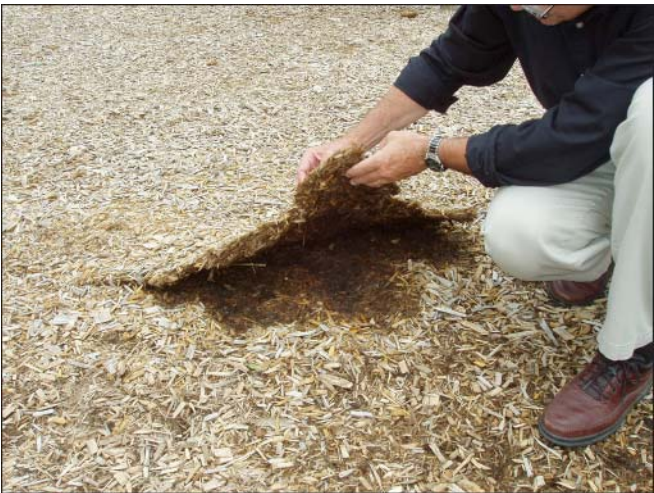
Figure 14—Exposed and torn edge of Vitri-Turf SEWF.

The durability of Vitri-Turf SEWF with exposure to weather was good and reflected similar experience with a prior exterior installation (Laufenberg and Winandy 2003). The integrity of the Vitri-Turf SEWF surface was maintained for the first 9 months. We then found that the edge of the Vitri-Turf SEWF had been lifted and the material torn off in large (0.2- to 0.8-m<sup>2</sup>, 2- to 8-ft<sup>2</sup>) plates and tossed about on the play surface (Fig. 14). This damage occurred at the unprotected and unsecured interface with the unstabilized EWF. It did not occur at the edge of the playground where the Vitri-Turf had bonded to the wood landscape ties that surround the area. Differential settlement of the Vitri-Turf SEWF and the EWF (due to extensive rainfall) was approximately 38 mm (1.5 in.). As a result of the damage, the Vitri-Turf SEWF was removed 9 months after installation. The material showed little evidence of fungal propagation or insect infestation. The thickness of the removed material, measured at 24 locations, was an average of 30.4 mm (1.2 in.).
